CANADIAN CENTRE
for Climate Change
and Adaptation

Prince Edward Island State of the Coast Report

November 2023

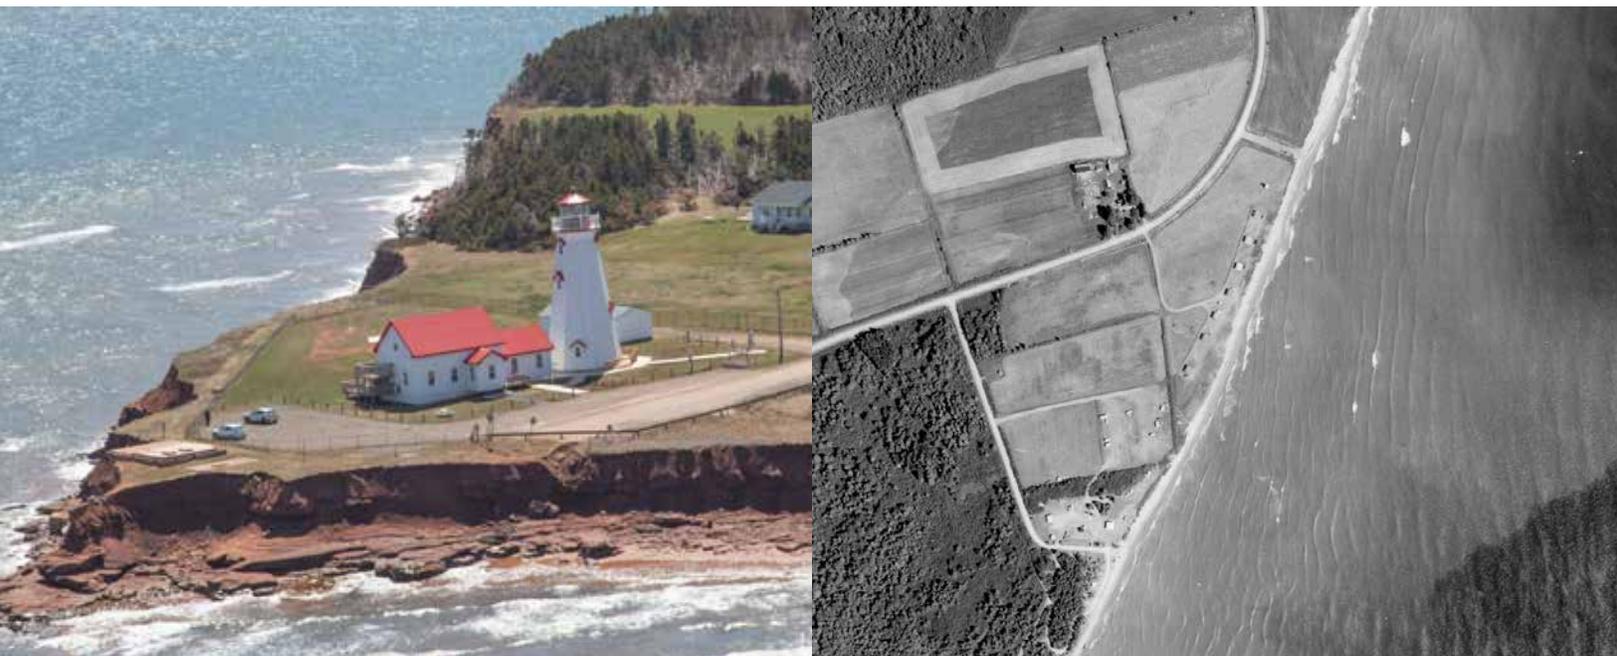
Figure 2. (left) East Point lighthouse with remnants of the previous foundation location at the edge of the bank (D. Jardine, 2023)

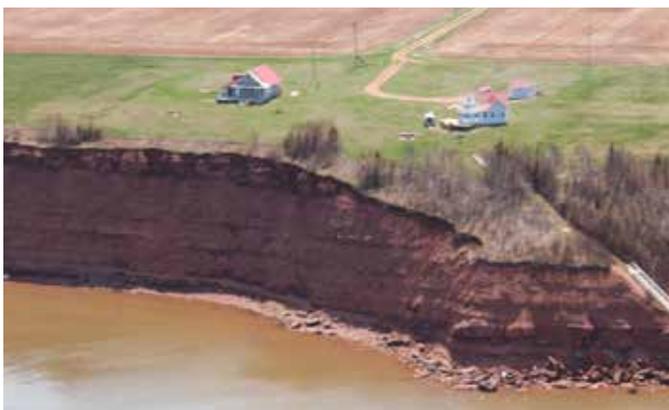
Figure 8. Sandstone cliffs in Orwell Bay (H. Parnham, 2023)

PEI's cliffs are found in all regions around the Island but vary in height and steepness. About 47% of the Island's exposed (coastal) shoreline and 19% of the estuary shoreline are classified as cliffs or bluffs. The coastline with the highest percentage of cliffs and bluffs is on the west end of the Island, between West Point and North Cape. The Island's highest cliffs, which reach about 35m in elevation, are found on the south shore in Orwell Bay.

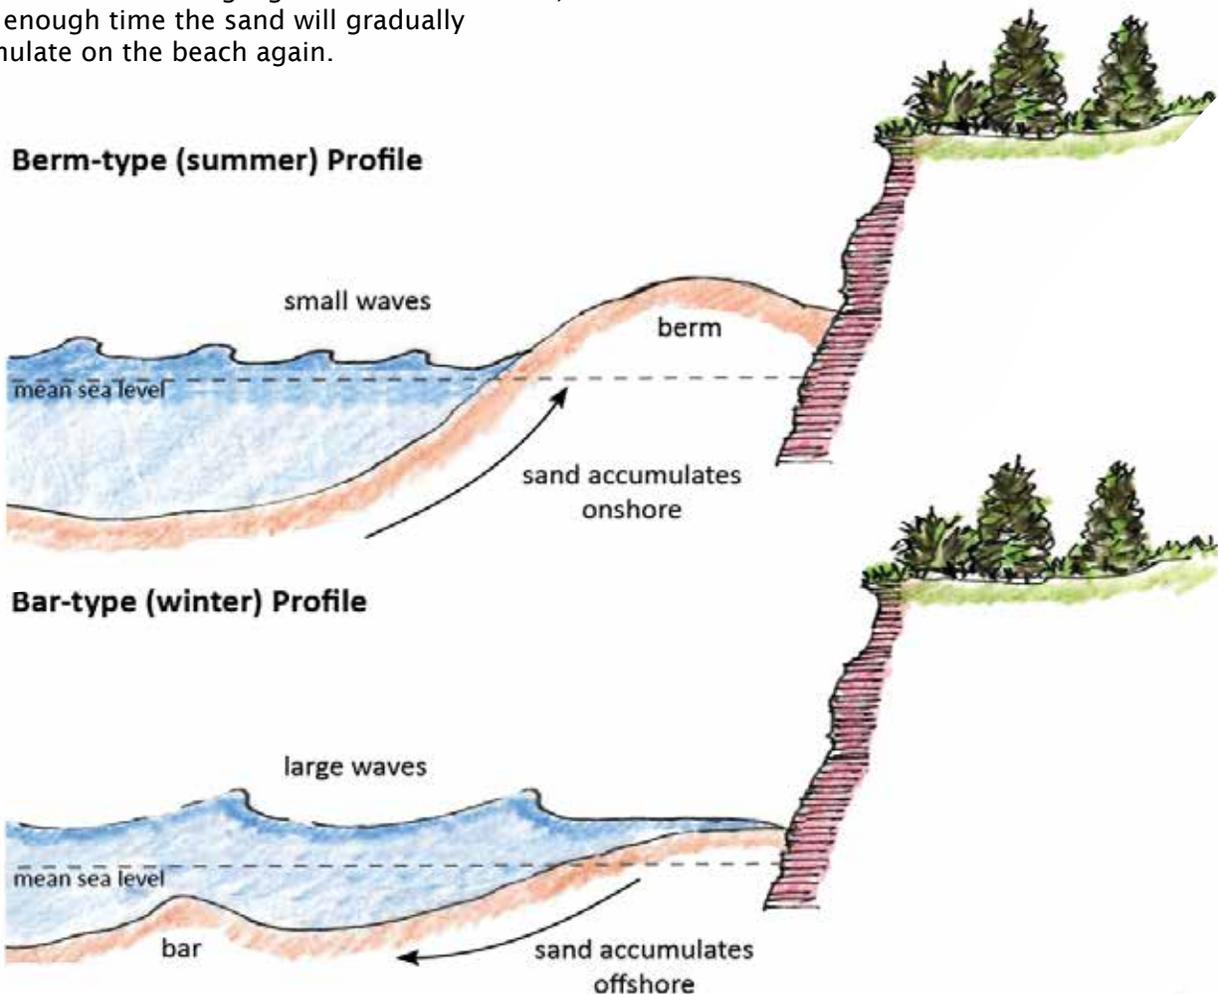
Figure 11. Sandy beaches are dynamic systems, depending on the wave conditions the sand may accumulate on the beach (foreshore) or may accumulate as sandbars in the nearshore. The loss of sand from a beach is different from erosion of the backshore. (H. Parnham; adapted from HEC - 25, 2020)

Sandy coastal systems are highly dynamic. Under normal, calm weather conditions, the sand that has accumulated in the nearshore zone appears as sand bars and offshore ridges. Small waves and tidal action gradually and continually transport this sand landward and deposit it on the sandy foreshore of the beach.

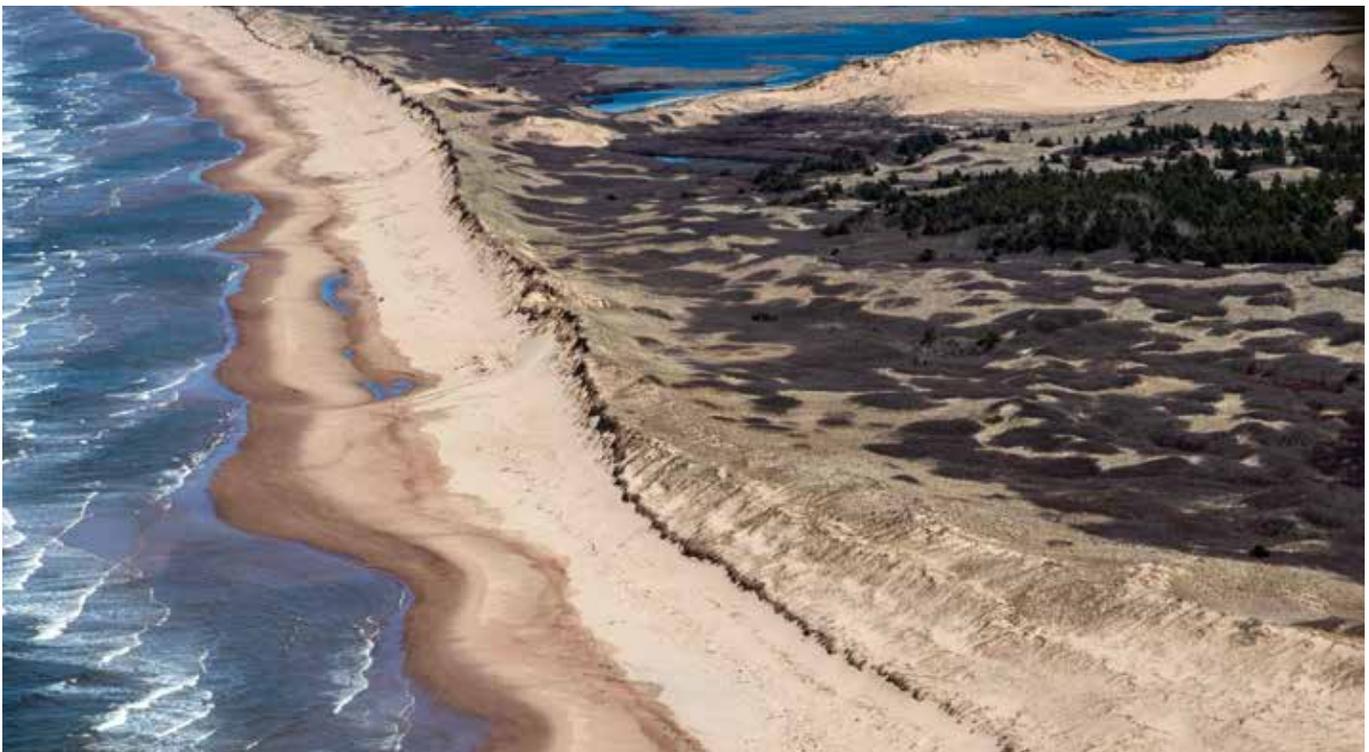
Figure 12. Parabolic dunes at Greenwich, PEI National Park (D. Jardine, 2023)

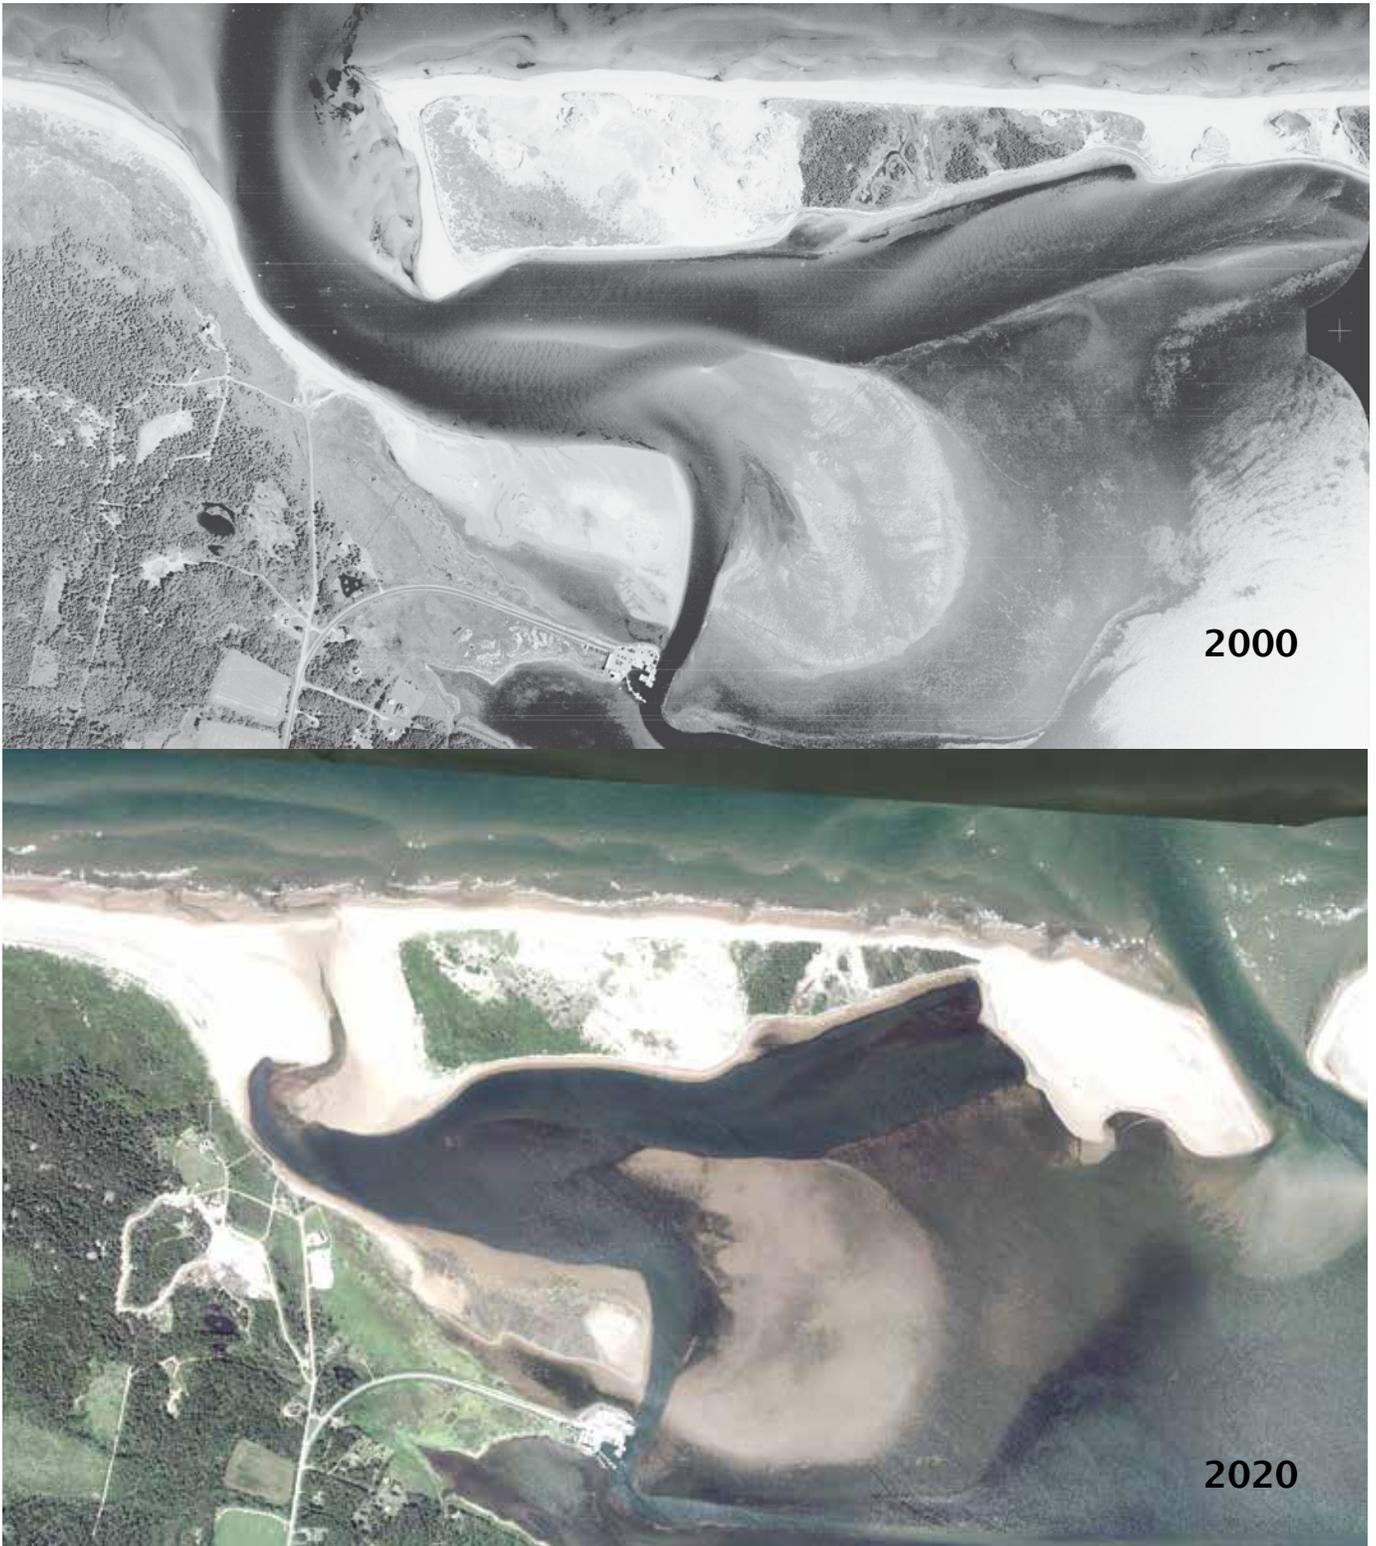
Figure 13. Sandspit and barrier island evolution at Tracadie Bay, 2000 and 2020 comparison. (Gov of PEI, 2000 and 2020)

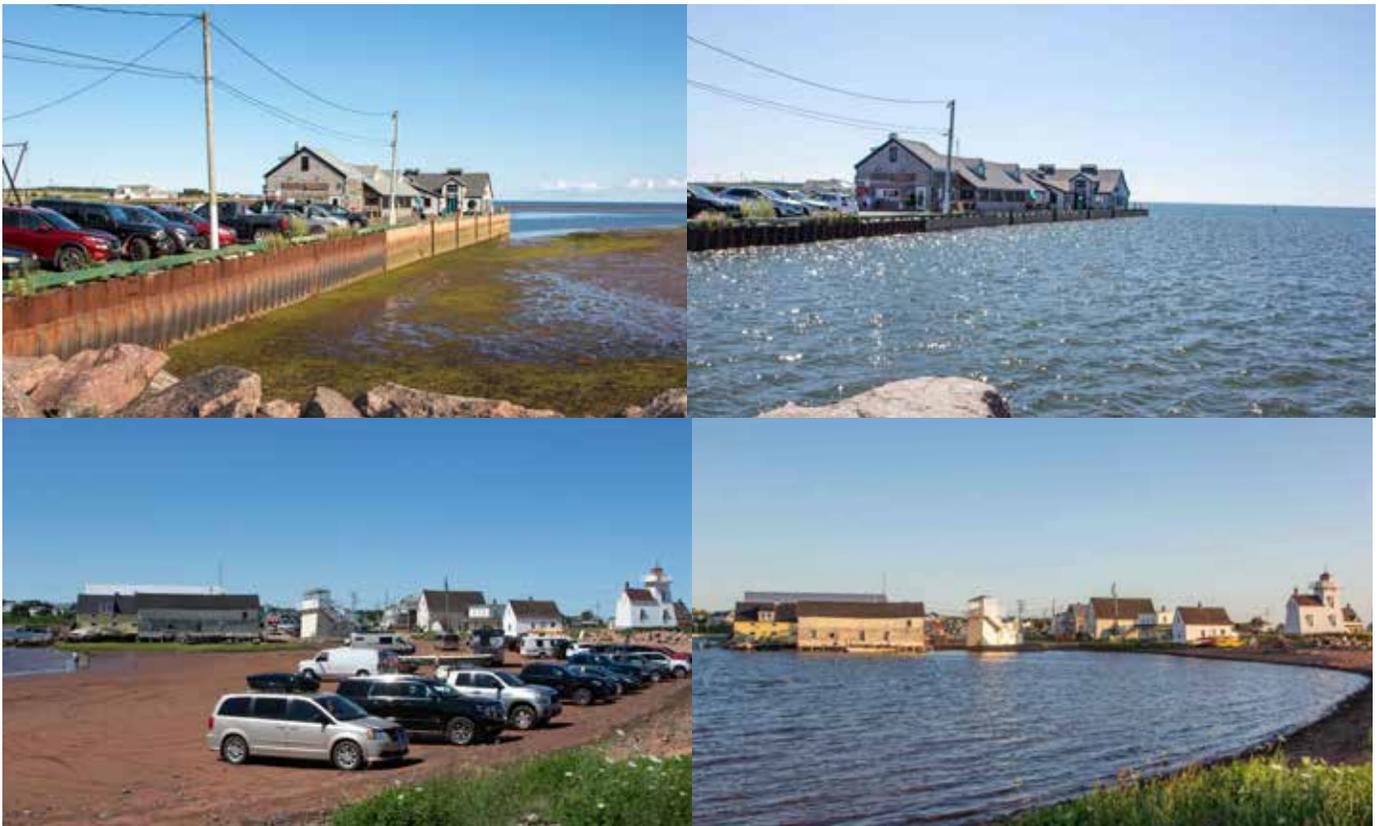
Figure 17. Low and high tide comparisons. The tidal range on the south shore at Victoria (top) can be over 2.8 m, where as the tidal range on the north shore near North Rustico is only about 1.1 m (bottom). (D. Jardine, 2023)

around the Island from both directions filling the Northumberland Strait, until the two surges meet in the middle near Hillsborough Bay (Coldwater Consulting, 2021). Consequently, the tidal range on the south shore is almost three times that of the tidal range on the north shore. When the south shore is experiencing a high tide, the north shore is experiencing a low tide, and vice versa.

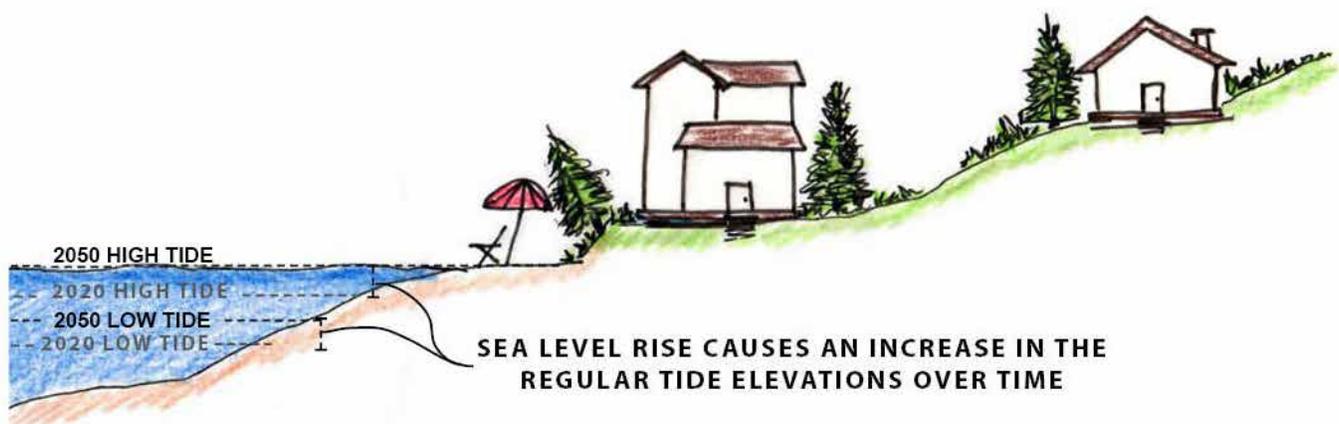
Figure 18. Gradual impacts of sea level rise on the coastal tidal range over time, 2020-2050, shown in still water conditions. (Government of PEI, 2021)

The impact of sea level rise on coastal properties and infrastructure on the Island will depend on the slope and topography of the land in the coastal zone. In areas with steep terrain (i.e., cliffs and bluffs), the shoreline may appear to be relatively unchanged. In low-lying areas, a small rise in sea level can cause permanent coastal flooding and shift the shoreline a significant distance inland.

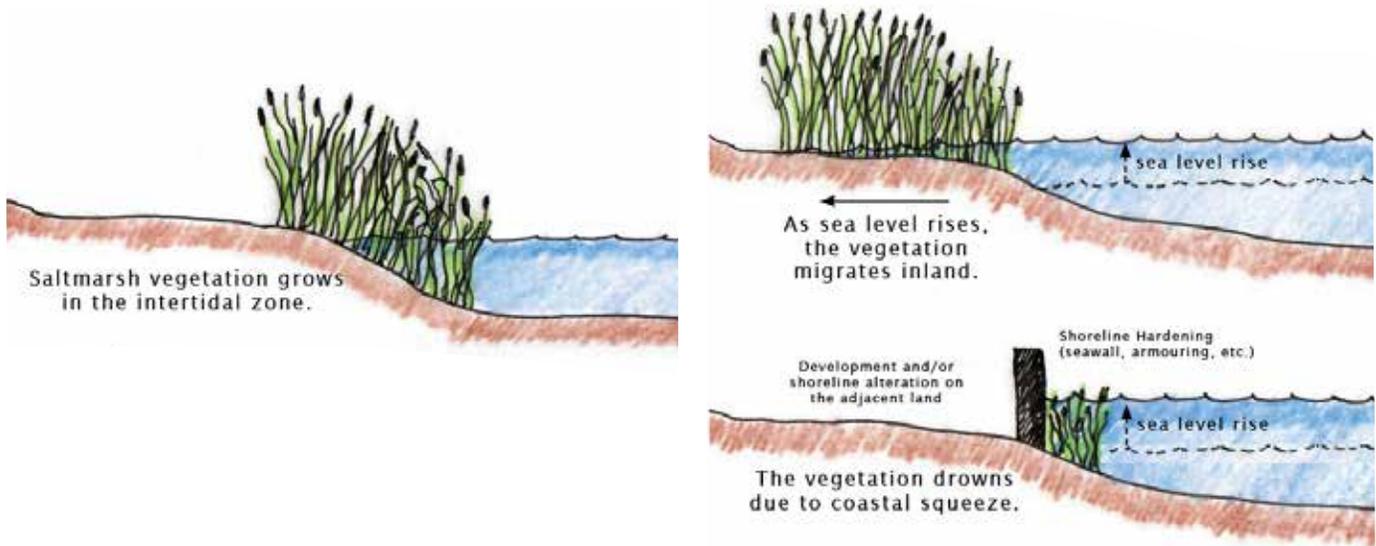
Figure 19. Sea level rise causes saltmarshes to migrate landward. If development or shoreline hardening prevents migration of the salt marsh and the vegetation will eventually drown. (H. Parnham; Adapted from VIMS, 2009)

Coastal squeeze is the term used to describe where shoreline development or infrastructure, including sea walls or shore parallel roadways, have reduced the space a saltmarsh has to migrate landward within the coastal zone. These structures prevent the ecosystem from adapting to climate change naturally (Chávez, 2021). A saltmarsh under stress due to coastal squeeze will be more vulnerable to storm events and will eventually drown as sea level rises.

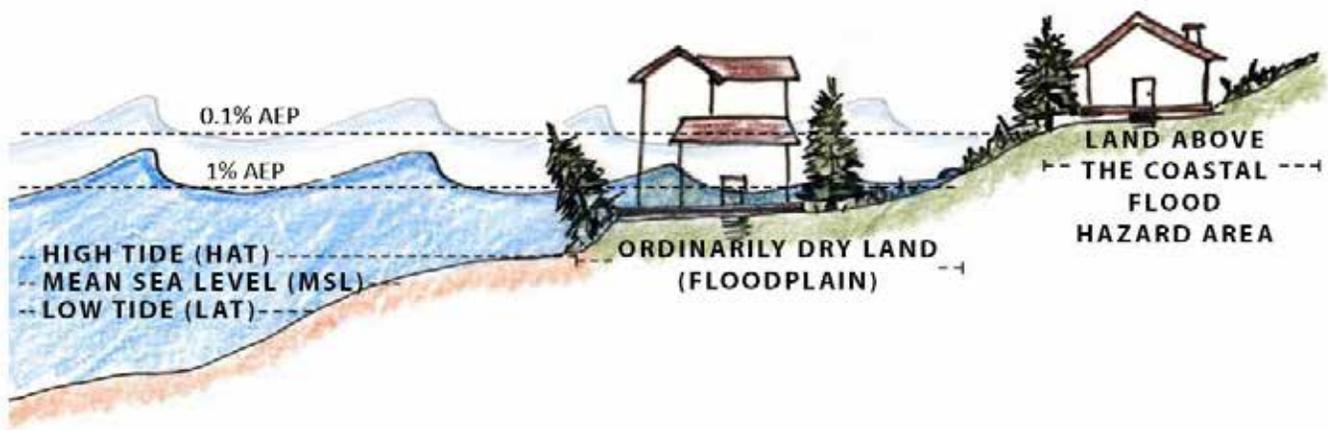
Figure 20. The coastline floodplain as defined by the extent of coastal flood waters during a storm surge with a 1% AEP = Annual Exceedance Probability (Government of PEI, 2021)

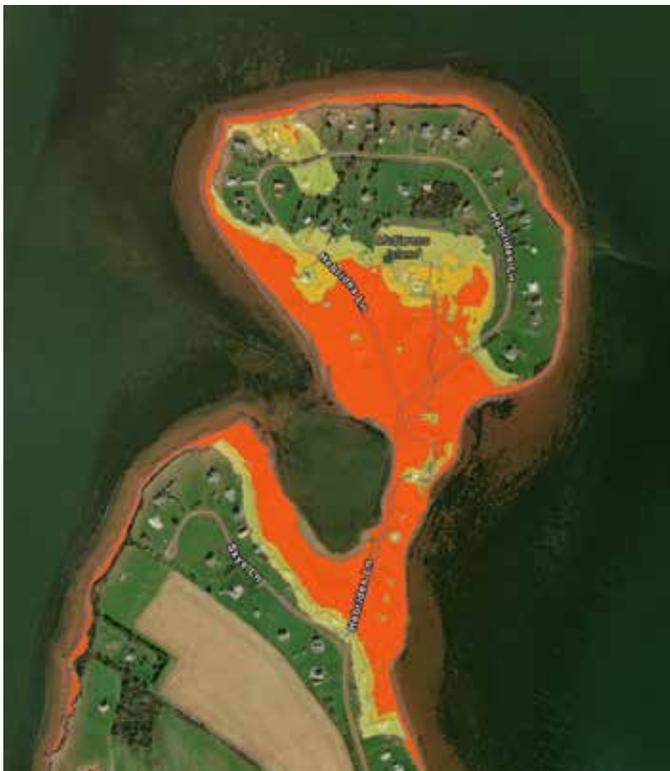
Figure 21. The high (red), moderate-high (orange) and moderate-low hazard zones are mapped for McEwens Island, commonly known as the Hebrides. (Gov of PEI, CHIP, 2023)

High Flood Hazard Zone - the area within the current coastal floodplain. This low-lying area is likely to experience flooding during extreme storm events and will be impacted more frequently as sea level rises and storm surge water levels reach higher elevations. Eventually, as sea level continues to rise, a portion of this area will be regularly under water during high tides.

Moderate-High Flood Hazard Zone - the area within the 2050 coastal floodplain. This area is less likely to experience flooding today; however, the likelihood of flooding during an extreme storm event will increase over time as sea level rises.

Moderate-Low Hazard Zone - the area within the 2100 coastal floodplain. This area is unlikely to experience coastal flooding now; however, the likelihood of flooding during an extreme storm event will increase over time.

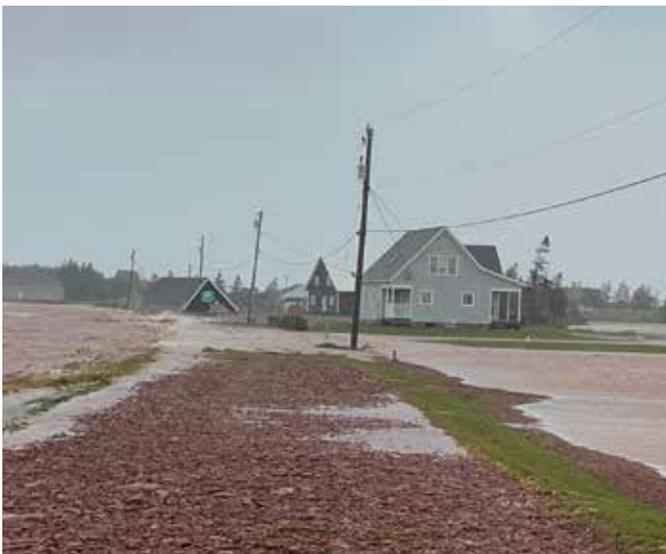
Figure 22. Storm surge flooding during Post-Tropical Storm Fiona, McEwan's Island, the Hebrides (shared with permission)

As an alternative to tide gauge measurements, high water marks (HWM) were surveyed on the ground following the event. Based on the HWM data, it is estimated the flood water in North Rustico reached an elevation of at least 2.4 m (CGVD2013), approximately 2.8 m above mean sea level (Jardine, 2023a). The storm surge water level exceeded the coastal floodplain elevation for the area, and more closely aligns with that of a 1-in-150-year event, with a 0.6% AEP (Jardine, 2023a).

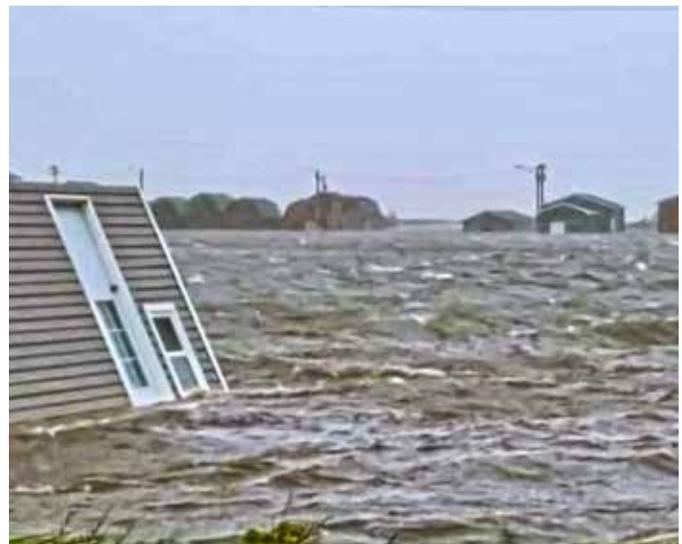
Figure 23. Building flooded by storm surge during Post-Tropical Storm Fiona, Malpeque Harbour PE (C. Wall, 2022)

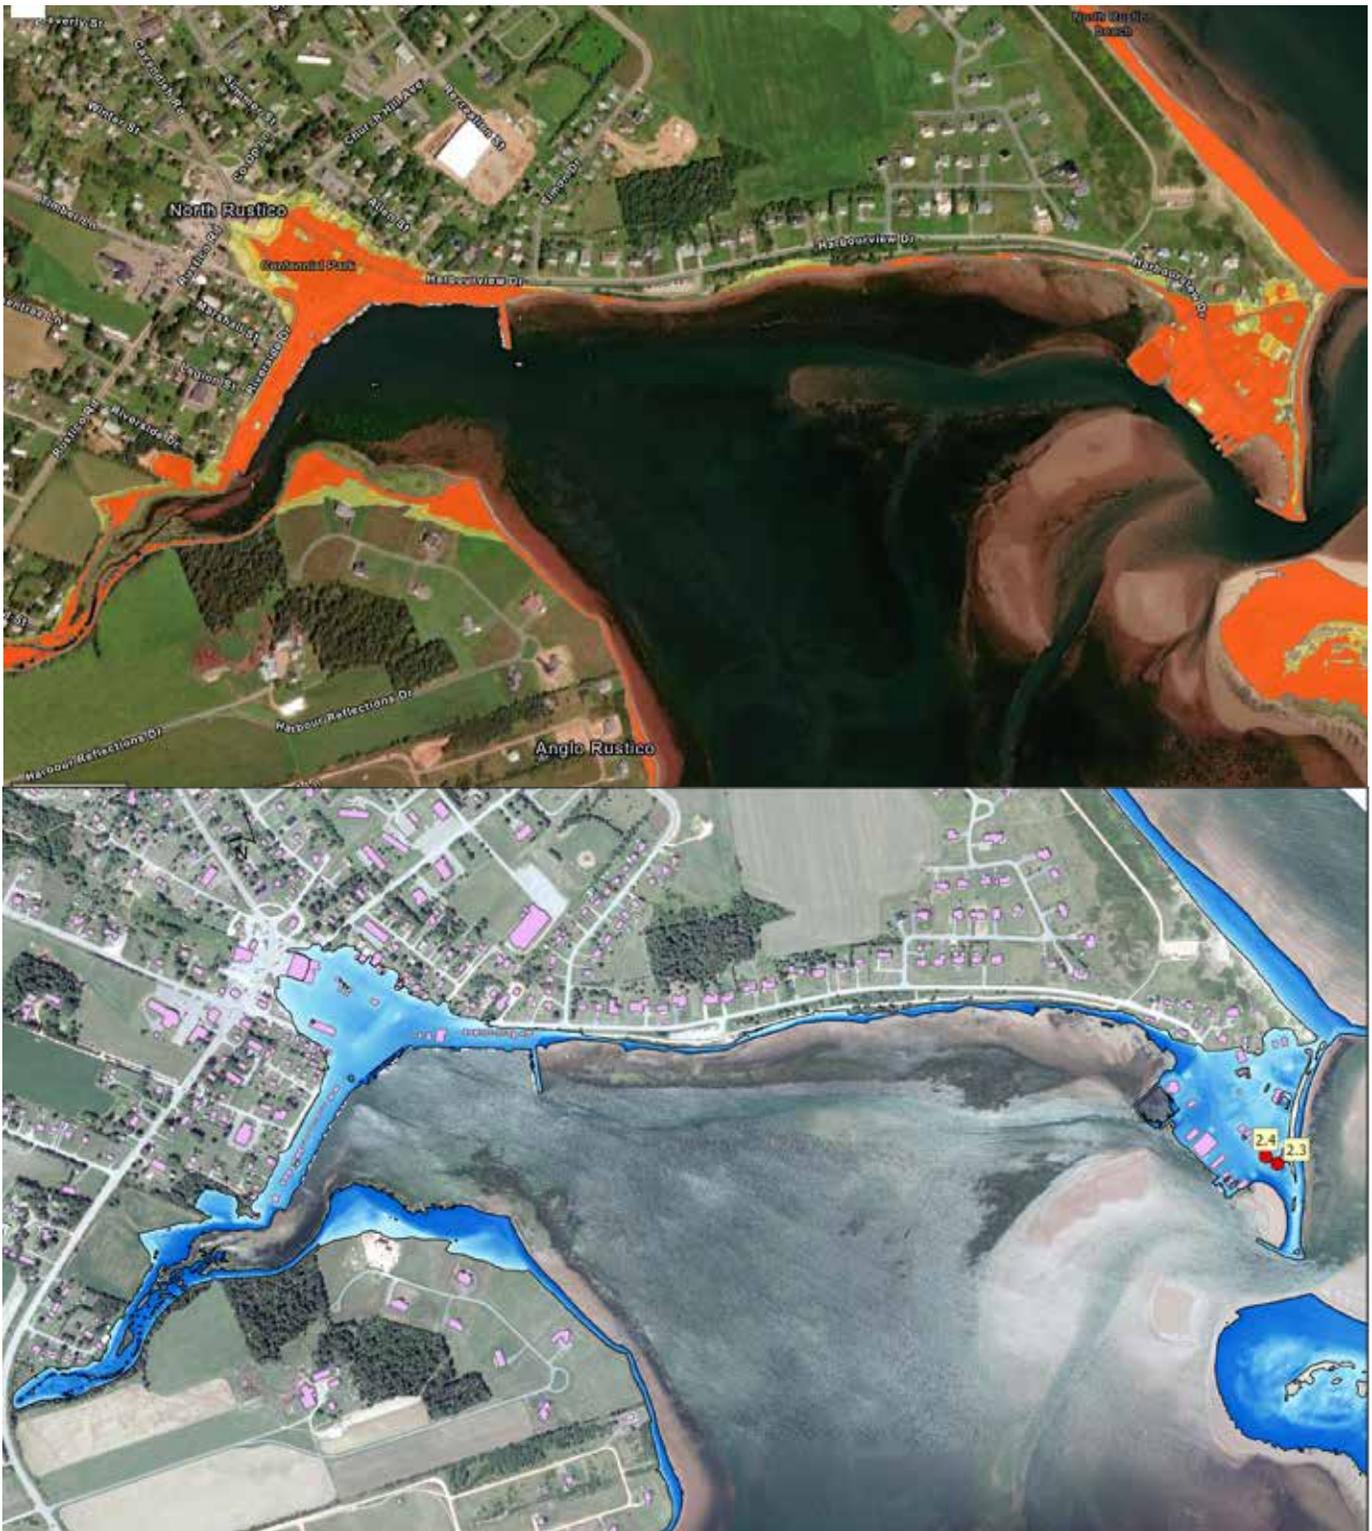
Figure 24. Top: Coastal floodplain (red) for North Rustico (Gov PEI, CHIP 2023). Bottom: Actual coastal flood extent (blue) following post-tropical storm Fiona based on high water mark survey elevations (Jardine, 2023a)

For more information on the HWM flood levels for different areas of the coastline, see the full report by D. Jardine (2023a) [here](#).

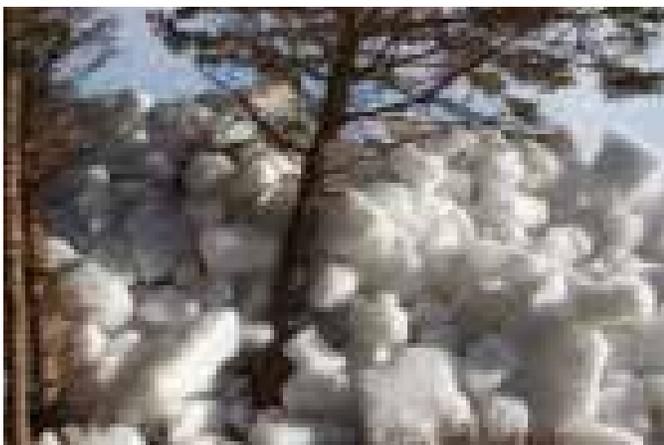
Figure 25. Ice Rafting, Cape Traverse (D. Jardine, 2018)

Ice rafting of the magnitude shown in the photos below is a relatively rare phenomenon, however it can result in significant damage to coastal structures located near the edge of the bank. In January 2018, Charlottetown recorded one of its highest water levels on record and ice blocks were rafted to a height of over 8 to 9 m in some areas on the south shore causing ice to be deposited on the top of cliffs.

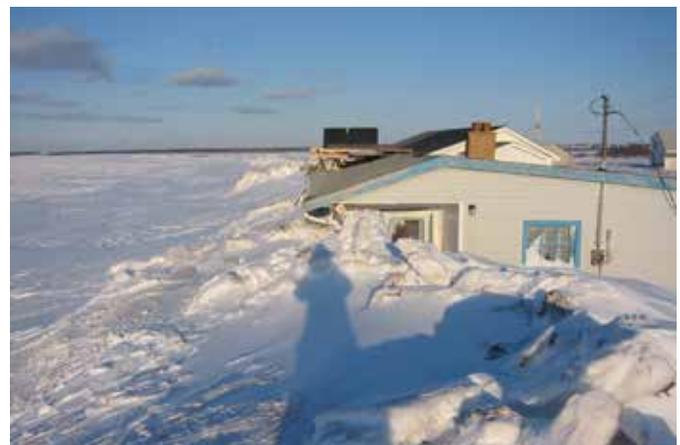
Figure 26. Ice Rafting, Maximeville (D. Forbes, 2004)

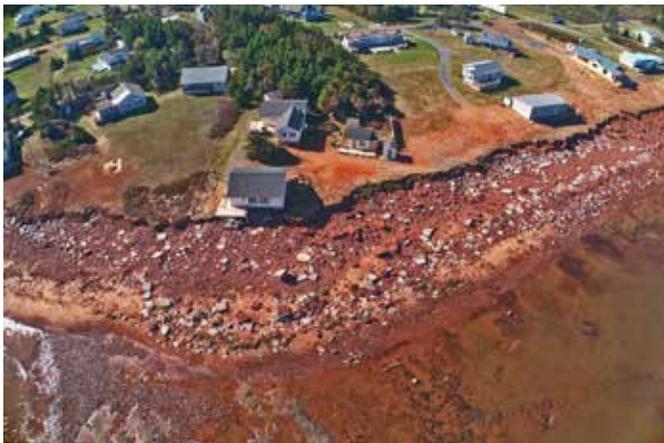
Figure 27. Coastal erosion and property damage at Savage Harbour, Pigots Point (UPEI, 2022)

During Post-Tropical Storm Fiona, storm surge water levels and wave action reached unprecedented elevations resulting in significant coastal erosion in some areas. At one property in Ebbsfleet in Western PEI, the horizontal loss of land due to erosion which left a V-shaped notch into the property was measured at approximately 26 m deep (*pers. comm.*, Jardine, 2023).

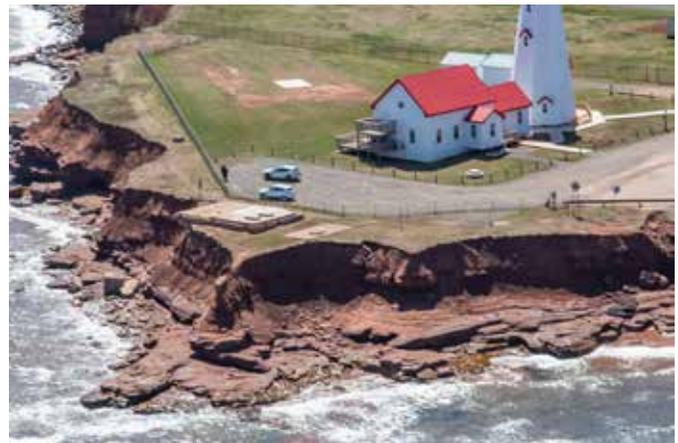
Figure 28. Coastal erosion at East Point where an old foundation is located at the top of the cliff (H. Parnham, 2023)

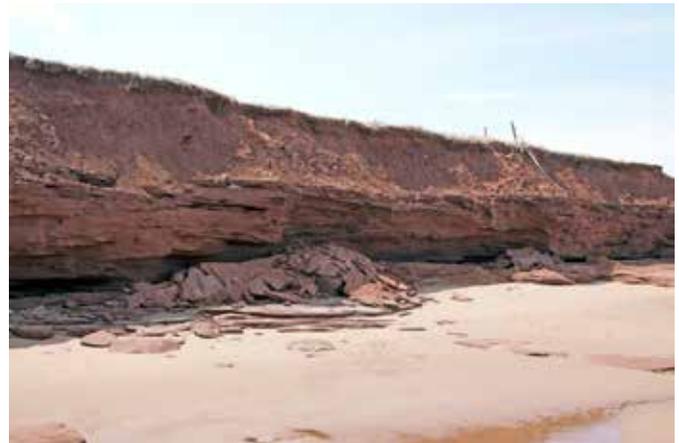
Figure 29. Cliff undercutting at Lower Darnley (D. Jardine, 2011)

Some coastlines in PEI experience erosion due to slope failure. When soil loses its stability, it is less able to support the weight of itself and any structures or vegetation above. Signs of recent slope failure are where large tufts of grass or other vegetation are visible on the material that has slid down the bank. Soil saturation can also result in relatively large slope failure which appears as a coastal slump or landslide.

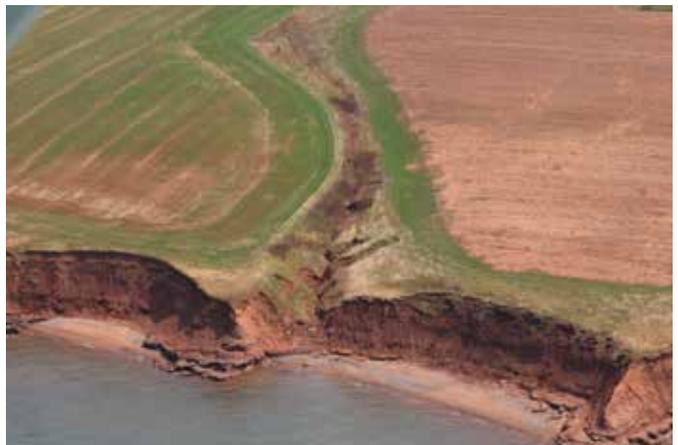
Figure 30. Stormwater gully on cliff at West Point (H. Parnham, 2023)

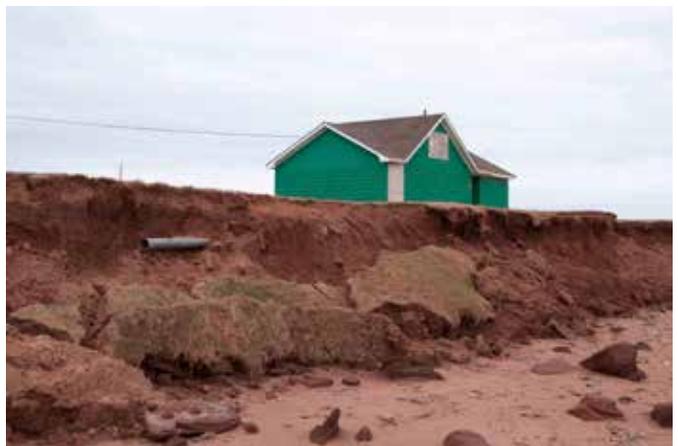
Figure 31. Soil slumping at Victoria Provincial Park (D. Jardine, 2011)

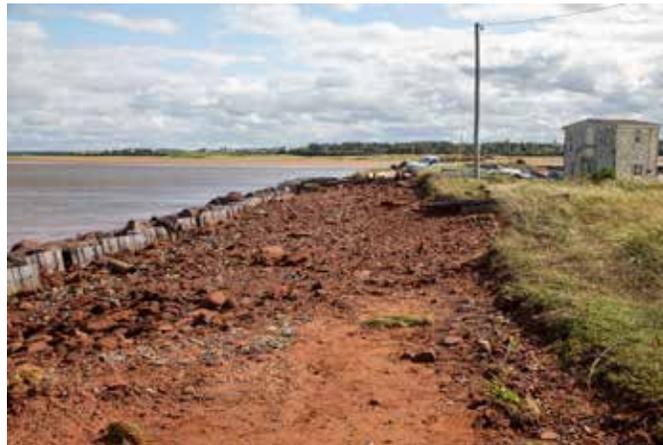
Figure 32. Sea wall overtopping at North Rustico (D. Jardine, 2019)

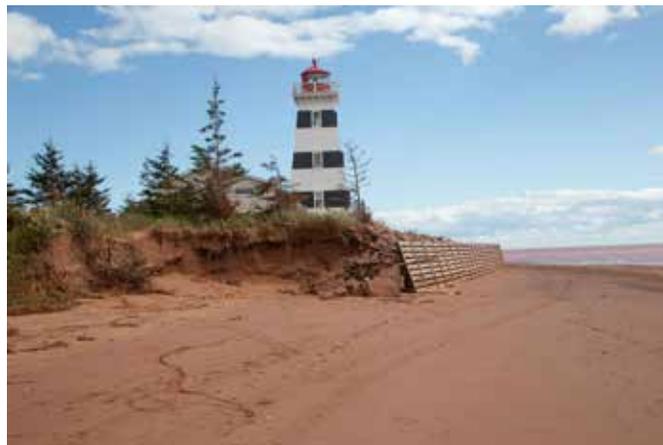
Figure 33. End-scouring on Langley Sea Wall at West Point (D. Jardine, 2019)

For example, the installation of new shoreline armouring (riprap, seawall, etc.) can reduce the rate of change in one location while accelerating the rate of change on adjacent properties or properties down shore if the beach is narrowed due to a reduced sand supply. Furthermore, extreme weather events, such as Post-tropical storm Fiona, can cause significant erosion in a particular area in a single day. The episodic nature of coastal erosion is not captured in average rates of change that imply a gradual, annual progression.

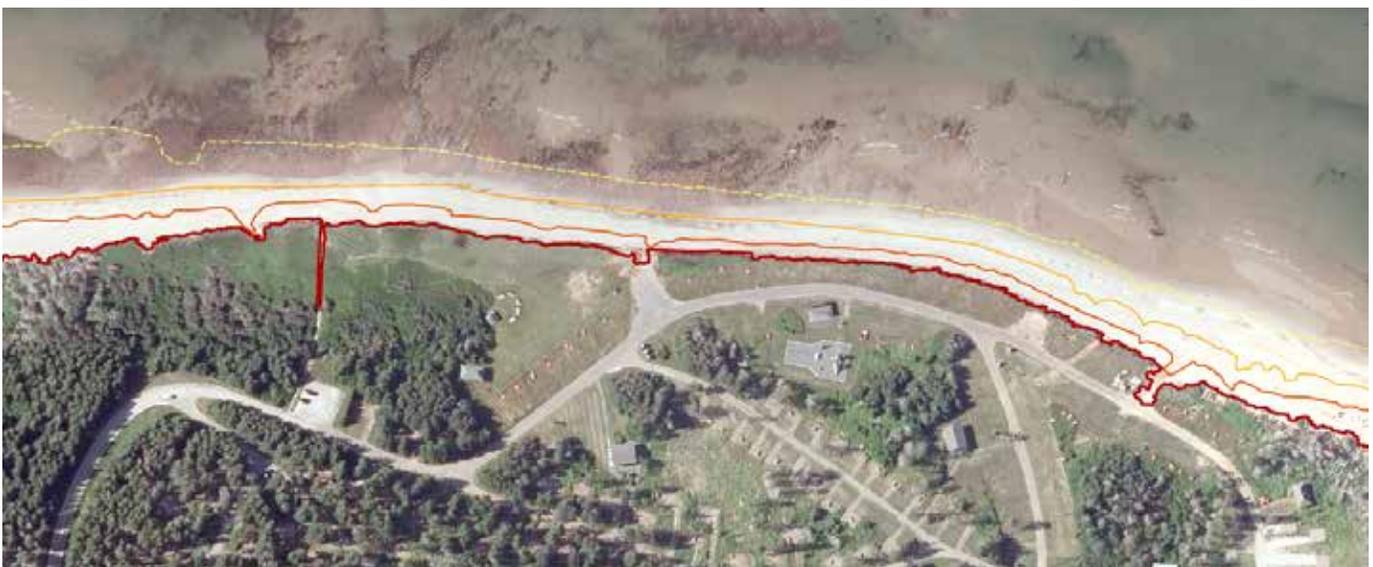
Figure 34. A comparison of the coastline location between 1968 (yellow), 2000 (light orange), 2010 (dark orange) and 2020 (red). Cavendish National Park Campground (Air photo: Gov PEI, 2020)

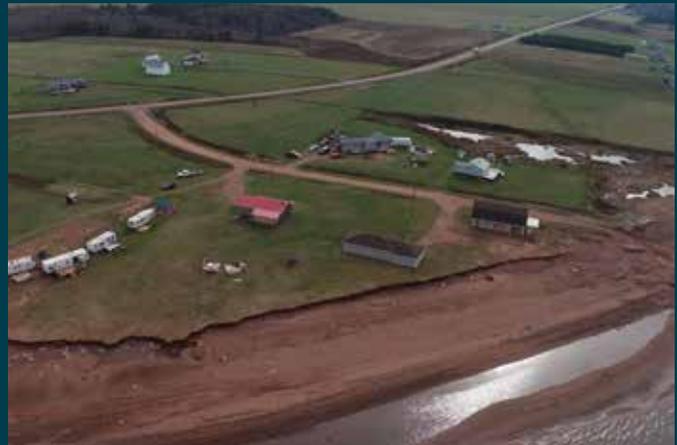
Figure 35. Drone imagery captured at Cape Gage (UPEI, 2023)

The 2022 summer field season captured the rate of change between 2021 and 2022, however measurements were taken prior to Post-Tropical Storm Fiona (September 2022). In November new measurements were taken at eight of the sites based on the observed impacts of the storm. Of these sites remeasured, the post-Fiona data from Cape Gage Road showed the highest single point of loss of any site over the entire monitoring programs records, at 17.56m, an increase of over three times from the previous highest recorded loss at just over 5m. With the post-Fiona results for these eight sites included in the overall analysis for 2021-2022, the annual average rate of change doubles from 0.33 cm/yr to about 87 cm/yr for the season (UPEI, 2023).

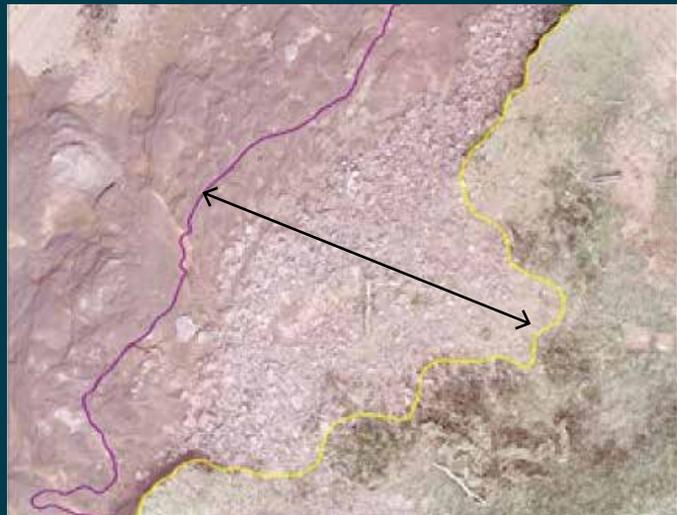
Figure 36. Drone orthomosaic for 2022 with coastlines comparing change over one year (purple is 2021, yellow is 2022) at Cape Gage showing a single point loss of about 17.5 m in a single year (UPEI, 2023)

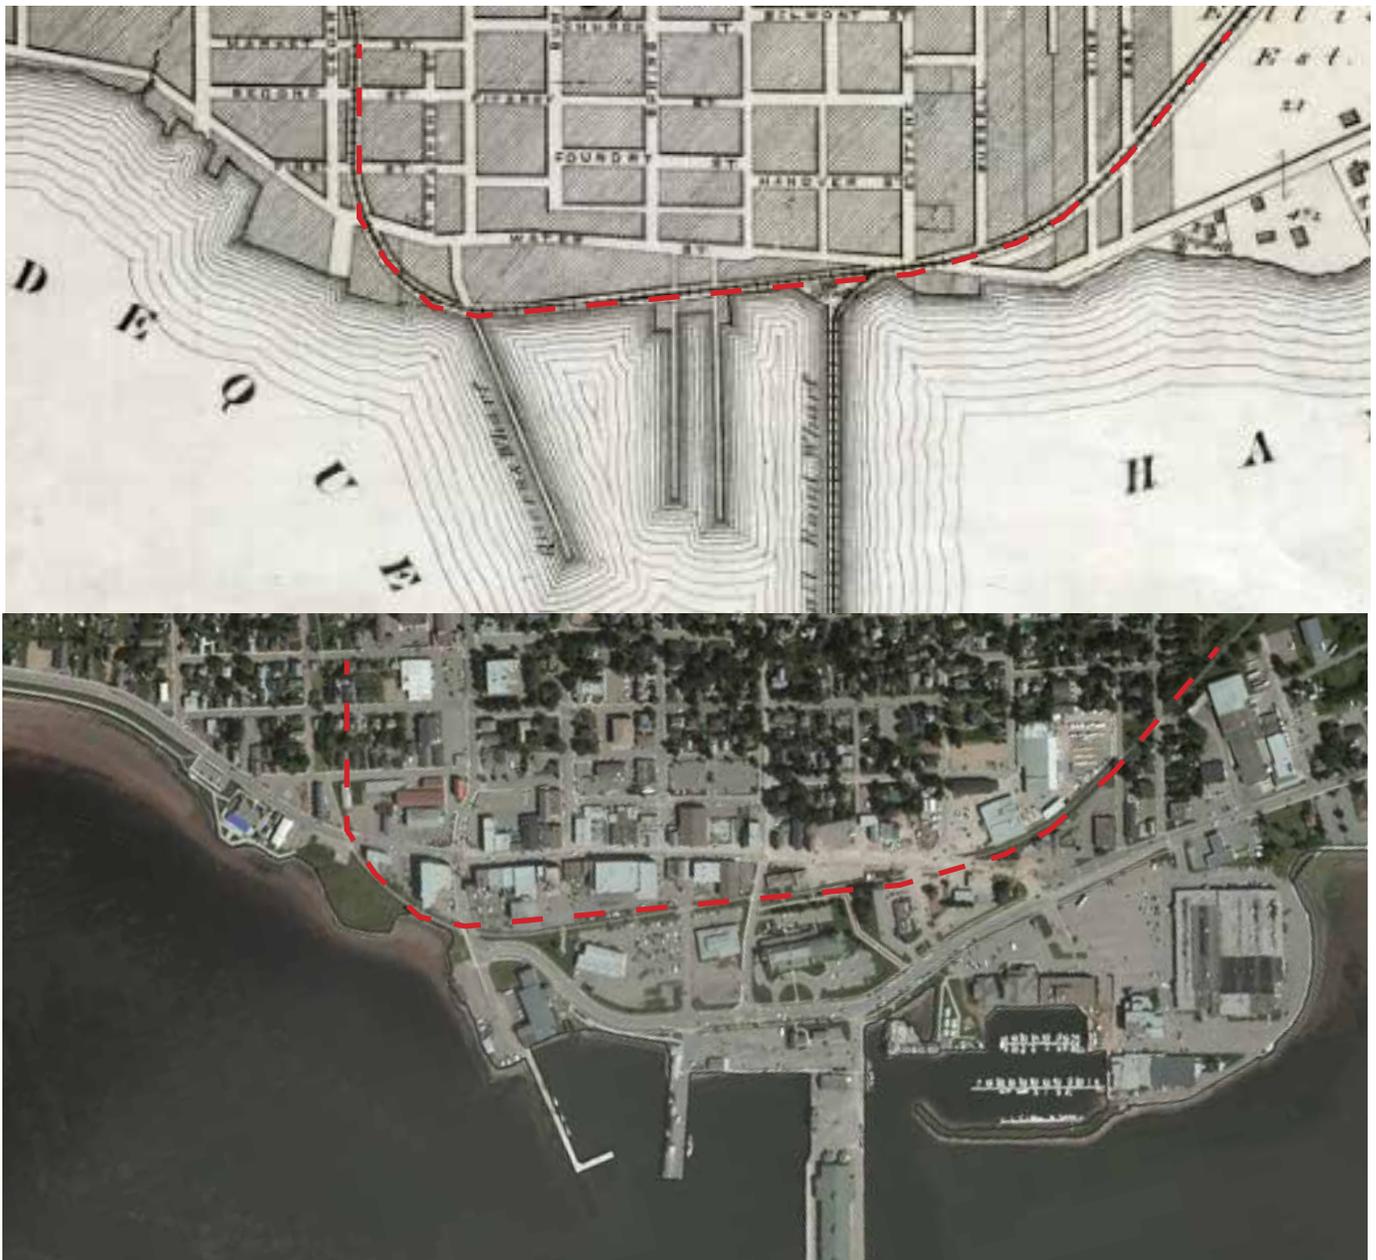
Figure 38. A comparison of the City of Summerside, Meacham's Atlas (1880) to 2020. Red line indicates location of rail line (1880) and Confederation Trail (2020). (Air photo: Gov PEI, 2020)

time about early colonial settlement patterns across the Island and in the developing cities and towns. The Meacham Atlas includes details of wharfs and seawalls indicating that the Island's coastline was altered in the earliest days of settlement.

Beyond their historical significance, these maps continue to serve as a reference for measuring natural and human constructed change in the Island's coastline over the past 250 years.

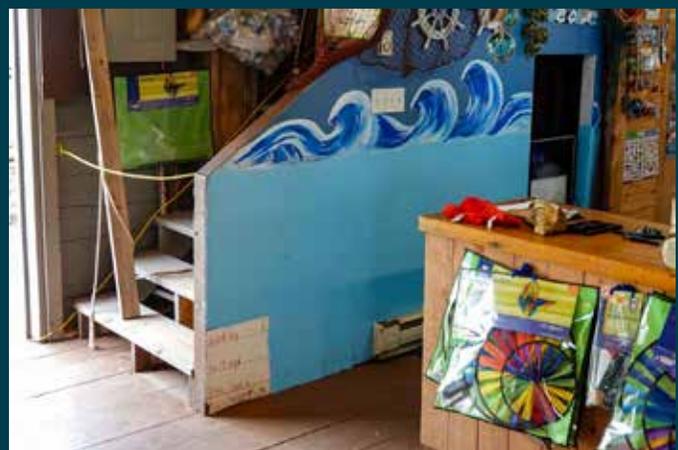
Figure 46. Storm Surge water levels marked on the Blue Wall in Sea Gulls Nest Giftshop, Rustico Harbour (D. Jardine, 2023)

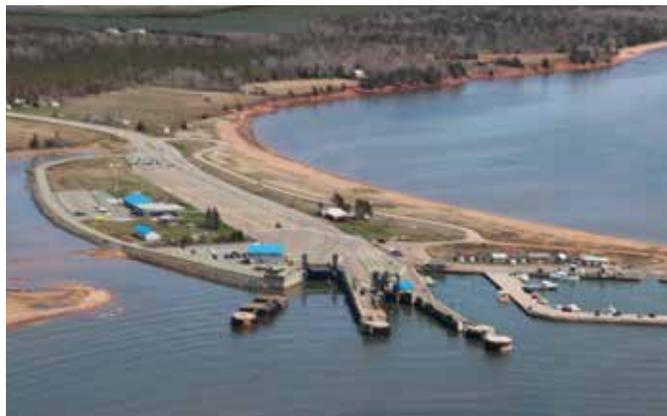
Figure 53. Wood Islands Ferry Terminal. (H Parnham, 2017)

The Wood Islands Ferry Terminal is operated by Northumberland Ferries Limited. The ferry terminal facilitates travel from May to December between Wood Islands, PEI and Caribou, NS. The ferry terminal facilitates up to 9 departures per day from each port during peak season. The cross-provincial journey is serviced by the MV Confederation a roll on/roll off passenger ferry vessel. [The MV Holiday Island went out of service in 2022 and the federal government announced recently that they have found a temporary replacement]. (CBCL, 2020b)

At the Wood Islands Terminal, a breach in the west barrier beach is expected to cause gradually increasing wave action and could lead to an increase in dredging requirements. While erosion risks will increase along the barrier beaches connected to the entrance breakwaters, most of this shoreline has already been armoured. A decrease in ice coverage in Northumberland Strait due to a warming climate could possibly lead to an extended shipping season at Wood Islands which may help contribute to the local economy.

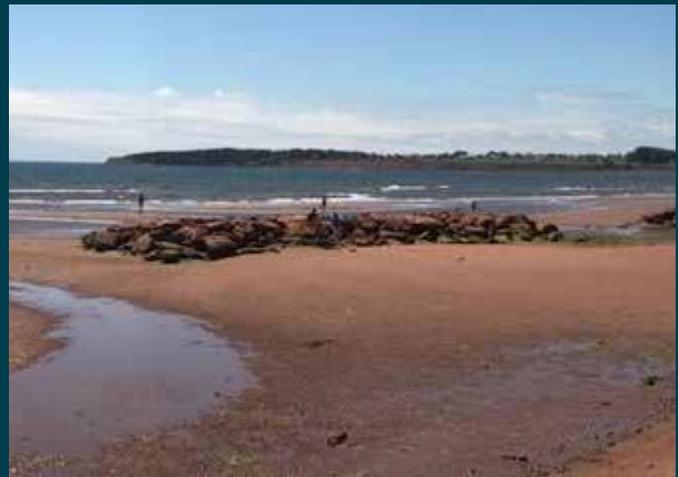
Figure 56. Intertidal reefs at low tide, Souris PEI (V. Leys, 2018)

Two artificial reefs were installed in the water in front of the causeway to baffle wave energy, protect the causeway, and capture sand. The reefs are considered a nature-based solution as they provide an opportunity for benthic (on the bottom of a body of water) and intertidal habitat and are constructed with PEI's local sandstone rock.

Using local material helps the structure maintain its natural appearance and contributes to the sand of the beach as the rock erodes over time. The artificial reefs have shown early success in capturing sand and rebuilding the beach behind them.

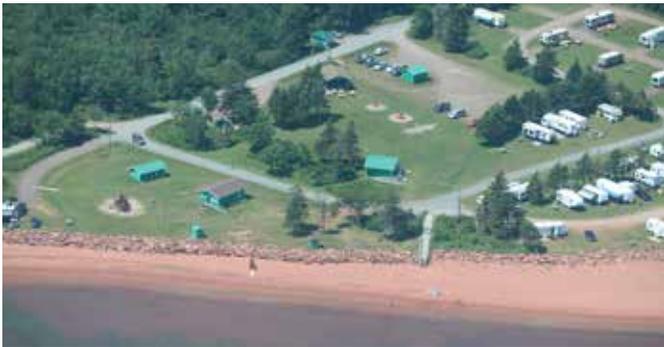
Figure 60. Jacques Cartier Provincial Park (H. Parnham, 2017)

The provincial Coastal Infrastructure Vulnerability Assessment (CIVA) found that Cedar Dunes Provincial Park (at West Point) and Jacques Cartier Provincial Park Campground (Kildare) are within high hazard areas for both coastal flooding and coastal erosion (GPEI, 2022). West Point, at Cedar Dunes has lost approximately 20m due to erosion since 1999, and it is projected that the problem will only increase in the future (Jardine, 2023). Recent efforts to stabilize the shoreline at West Point involved the installation of offshore reefs. While the reefs are not designed to prevent coastal flooding, it appears they have been successful in capturing sand on the foreshore of the beach which will help reduce the impacts of wave action that causes erosion. PEI sandstone armour rock was installed along the full length of Jacques Cartier Provincial Park in 2015.
