CANADIAN CENTRE
for Climate Change
and Adaptation

Prince Edward Island State of the Coast Report

November 2023

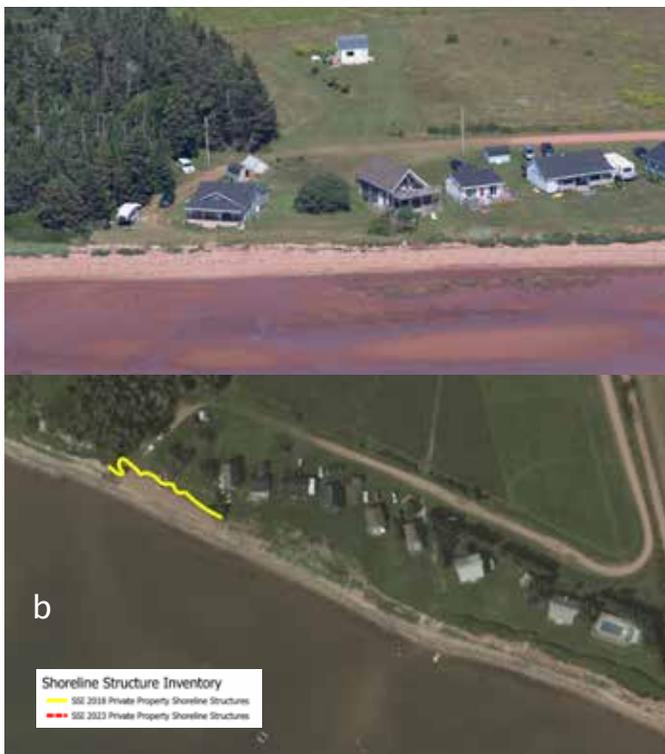
Figure 65. (a) Aerial survey photo of shoreline structures (D. Jardine, 2017); (b) corresponding SSI 2018 map over 2010 orthophoto. Argyle Shore, PE

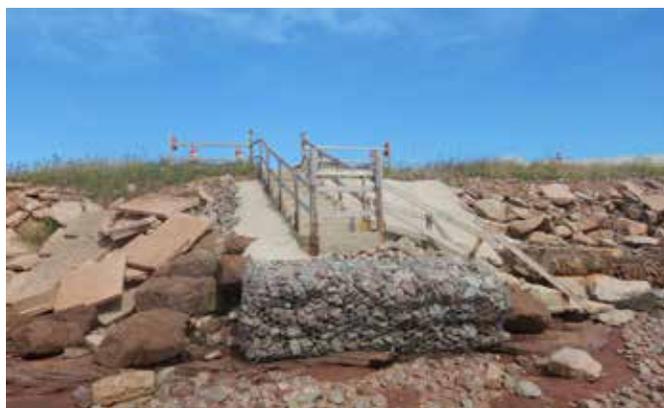
Figure 67. Beach access reinforced with poured concrete, concrete slabs and gabion baskets (H. Parnham, 2018)

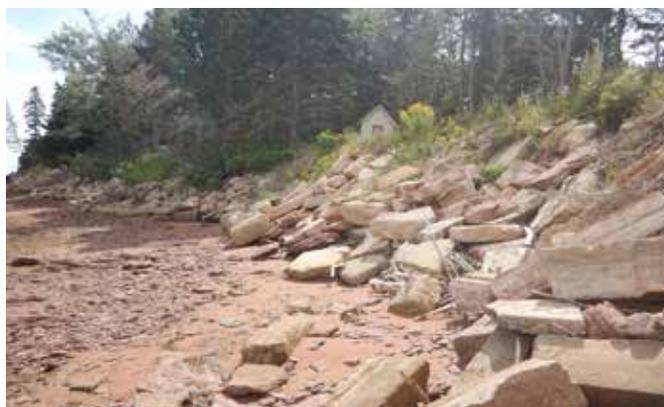
Figure 68. Typical residential shoreline armoring with old concrete/construction debris (H. Parnham, 2018)

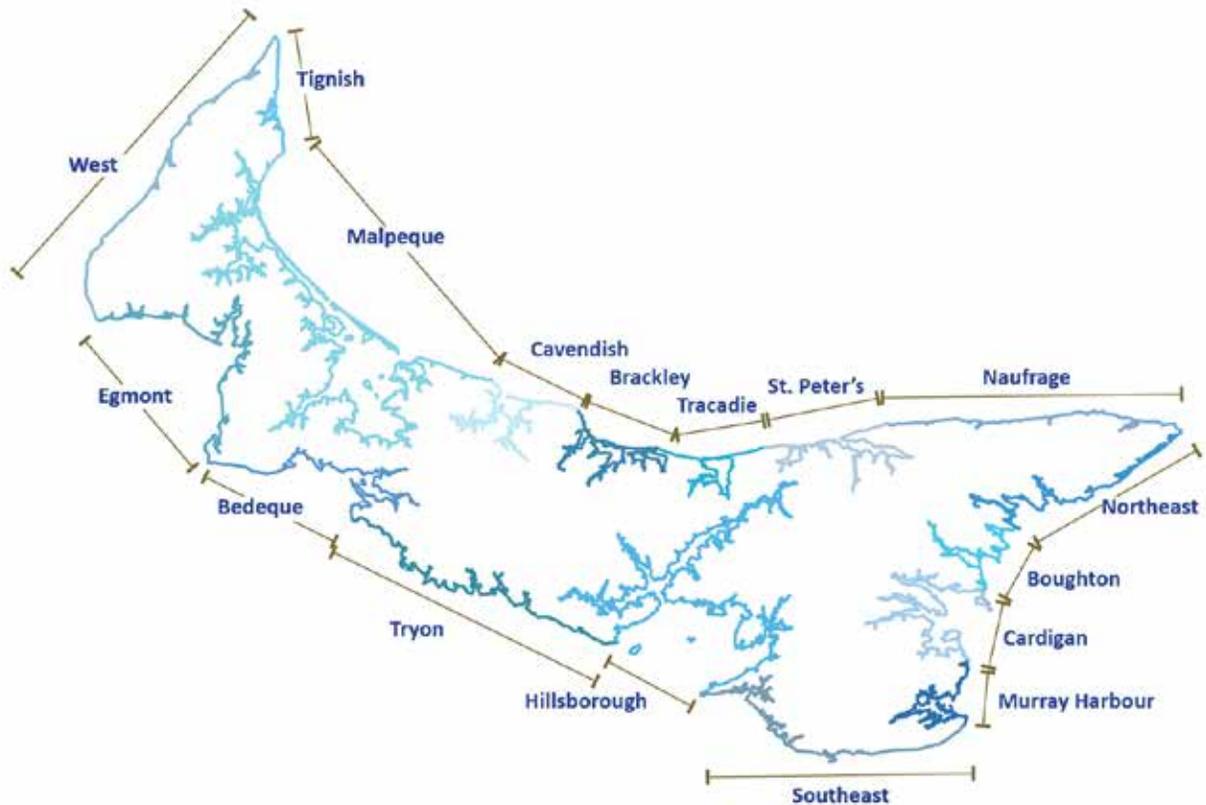
Figure 70. PEI Littoral Cells (Adapted from Coldwater Consulting, 2012)

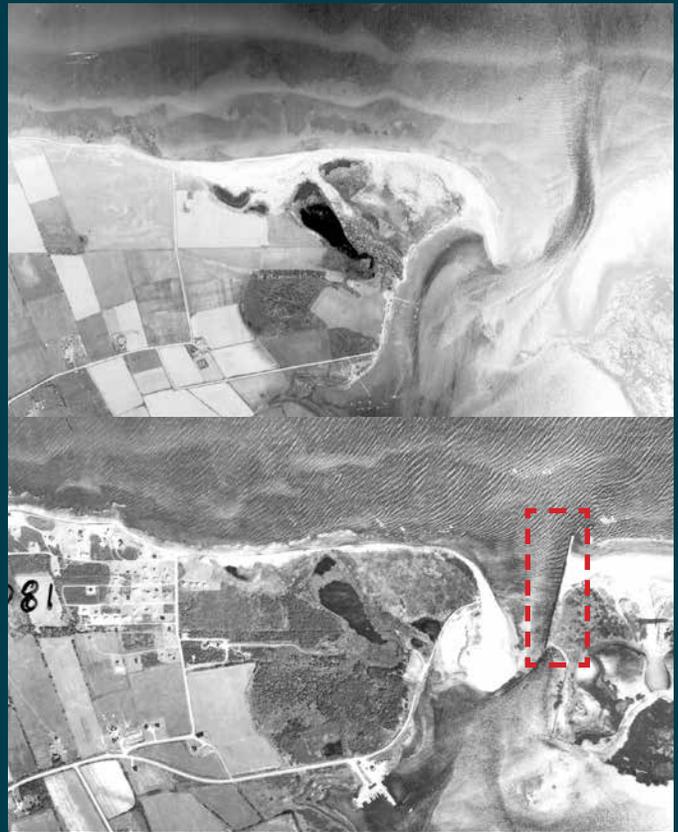
Figure 71. Comparison of the sandy beach conditions at Savage Harbour 1936 (before the breakwater) and 1990 (after). Breakwater outlined in red..

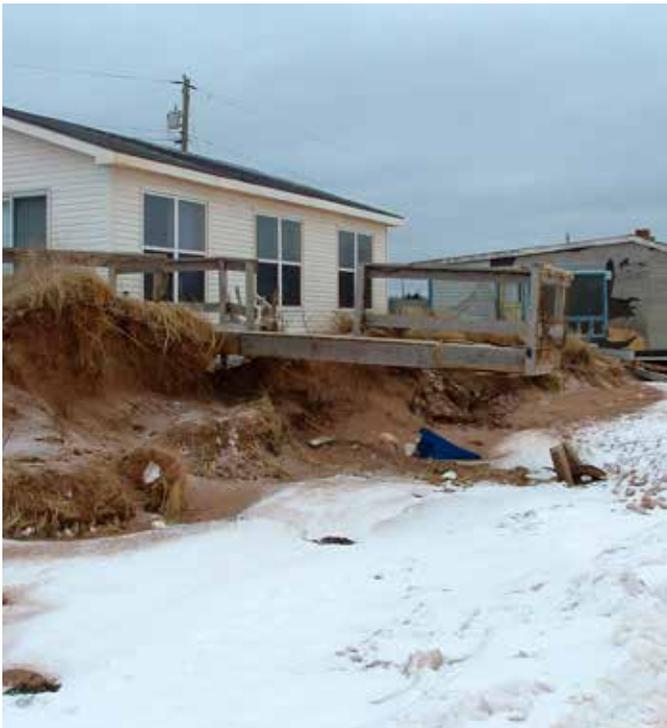
Figure 73. Waterfront cottages damaged in a severe storm event. Maximeville, Egmont Bay PE (D. Jardine, 2006)
